# Analysis of coastal flooding and erosion at the German North Sea Coast – two examples

T. Albers & N. von Lieberman

*Hamburg University of Technology, Hamburg, Germany*

**ABSTRACT:** The coastal protection of the German North Sea Coast is characterized by dikes and sandy coasts. By the means of two examples the risks of flooding have been analyzed. The consequences of coastal flooding due to dike failure in the city of Emden have been assessed. The risks of coastal dune erosion will be described at the example of the island Amrum.

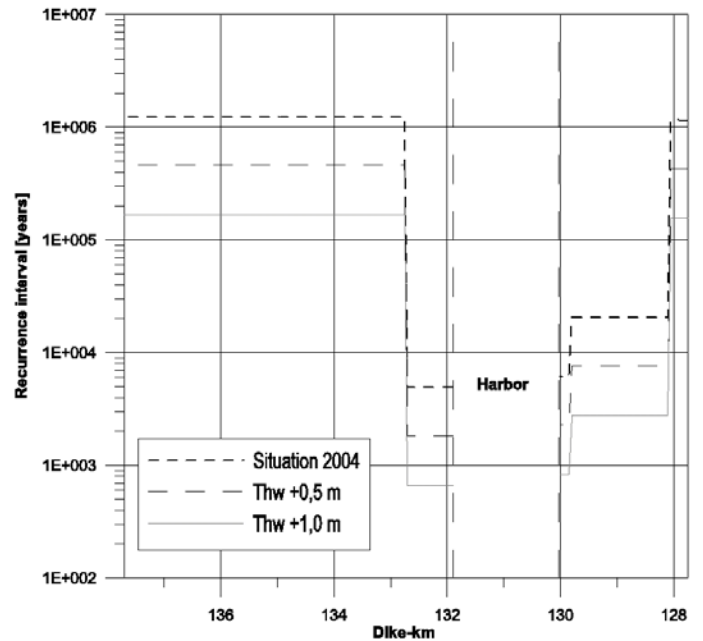
Figure 1. Recurrence interval of dike failure in the region of interest. Situation 2004 and increasing tidal high water.

At chosen profiles in the dike line the probabilities of failure were calculated. The area of the harbor was excluded because here a different mechanism of failure is crucial. Figure 1 shows the results of the calculation. The recurrence intervals of failure (the inverse of the failure probability) are very high due to the immense heights of the dikes. Even in case of an increasing tidal high water the recurrence intervals remain on a high level. The effect of increasing wind velocities is low in comparison with an increasing water level (Figure 2). Conspicuous are the different levels of recurrence intervals along the dike

line according to different heights and dike geometries. The highest levels are located at the Volkswagen factory (dike-km 135) and at housing areas east of the harbor (dike-km 128).

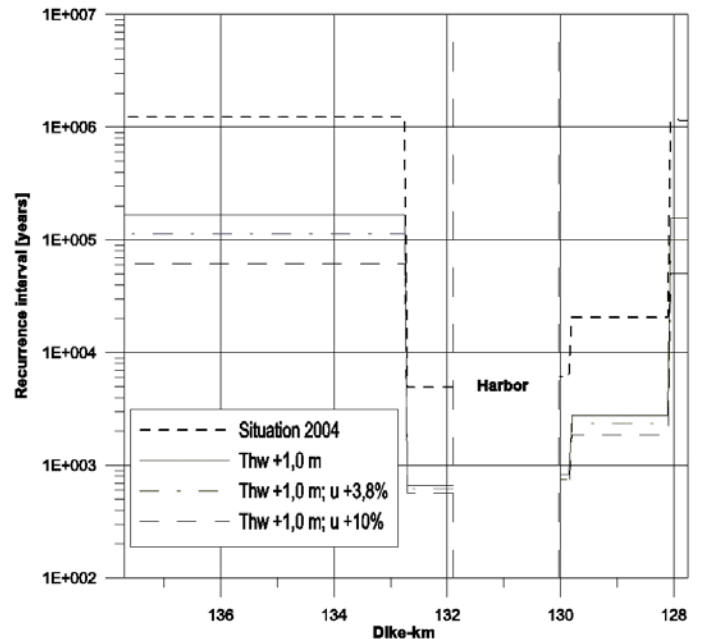
Figure 2. Recurrence interval of dike failure in the region of interest. Increasing tidal high water and wind velocity.

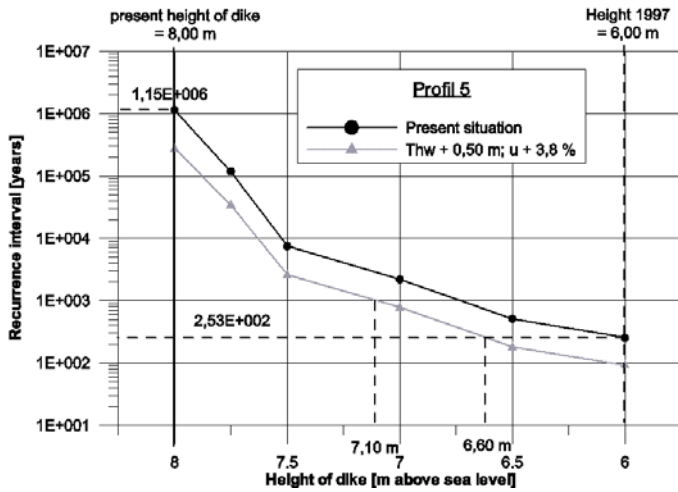
Figure 5. Dependency of recurrence interval of dike failure on dike height.

Figure 5 shows the recurrence interval of dike failure depending on the height of the dike. Profile 5 is located to the east of the harbor of Emden near to a housing area. To keep the recurrence interval constant at an increase of the tidal high water of 0.5 meters and of the wind velocity of 3.8%, an upgrading of the dike to 0.60 meters would have been necessary in the year 1997. Due to the dike heightening of 2 meters until the year 1999 the recurrence interval was reduced clearly.

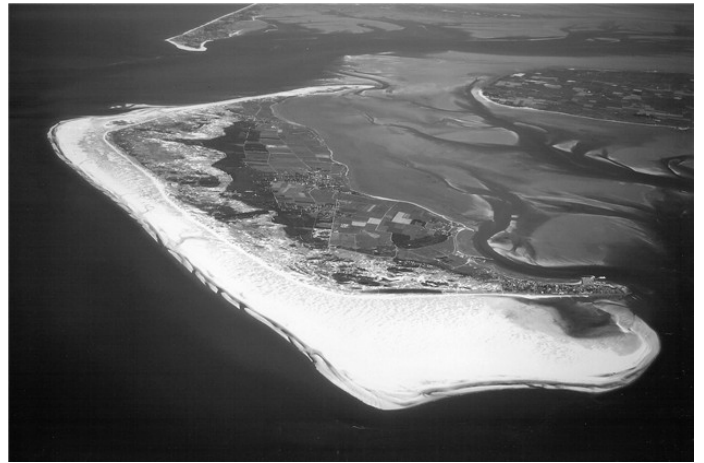
Figure 6. The island Amrum.

Amrum (Figure 6) is an island with a size of 20.46 km<sup>2</sup> and therefore the smallest of the three North Frisian Islands. It borders in the east at the wadden sea and in the west a dune area ranges over the complete length of the island. To the west of this dune belt follows the so-called Kniepsand, a sandbank of 15 km length and 1 km width located a bit above the mean high water. The main purchase of the 2300 inhabitants is tourism. The three villages of the island are located at the eastside.

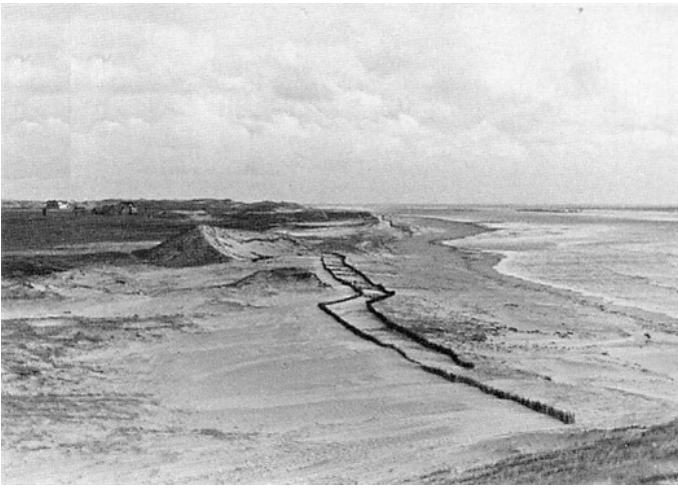
Figure 7. Destruction of dunes during a storm surge in the 1960's.

The dune area is extended over 45% of the island and builds the shore protection at the west side of Amrum. The dunes are of an elevation up to 30 meters above sea level. The preliminary sandbank offers an additional protection in case of a storm surge. During a heavy storm surge in the 1960's parts of the dunes in the north of the island were destroyed. Figure 7 shows the extend of the destruction and the power of the sea. It also clarifies the necessity to observe the dunes and to repair damages with biotechnical coast protection measures. Otherwise a separation of the northern part of the island may occur.

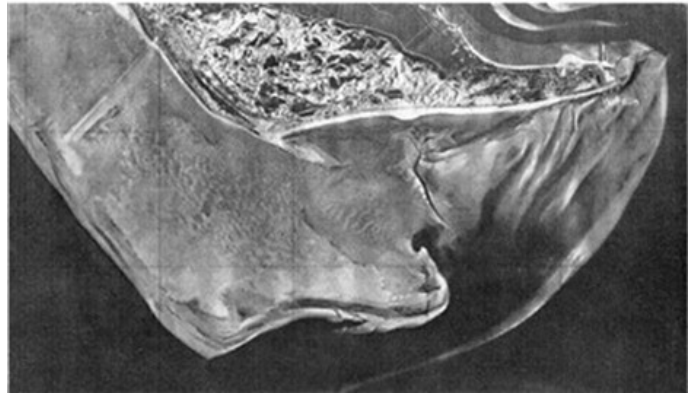
Figure 9. Aerial photo of the southern part of Amrum 1937.

Further changes of the shape of the island can be observed in the south: Since the 1950's a "nose" is moving towards the south end of Amrum. This development is shown in the Figures 9 and 10.

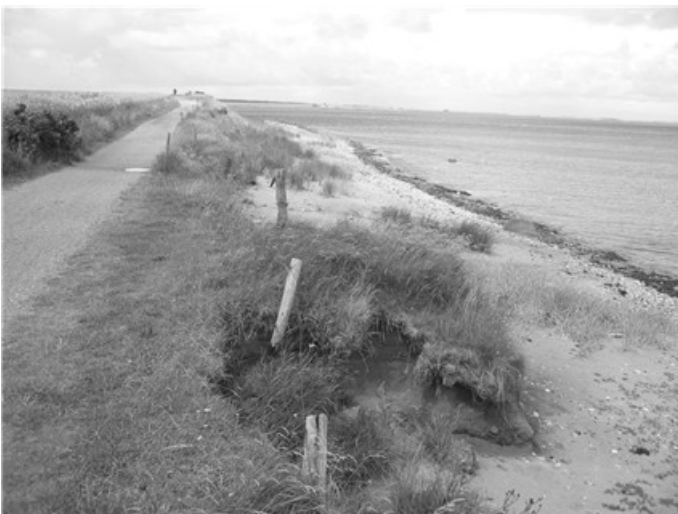
Figure 8. Erosion at the eastside of Amrum.

A huger part of the eastside underlies a natural erosion. In this region bigger losses of land occur every year (Figure 8).
